UNDERWATER FACILITIES INSPECTIONS & ASSESSMENTS

NORFOLK NAVAL SHIPYARD
PORTSMOUTH, VIRGINIA

FPO-1-81(19) AUGUST 1981

OCEAN ENGINEERING AND CONSTRUCTION PROJECT OFFICE
CHESAPEAKE DIVISION
NAVAL FACILITIES ENGINEERING COMMAND
WASHINGTON, D.C. 20374

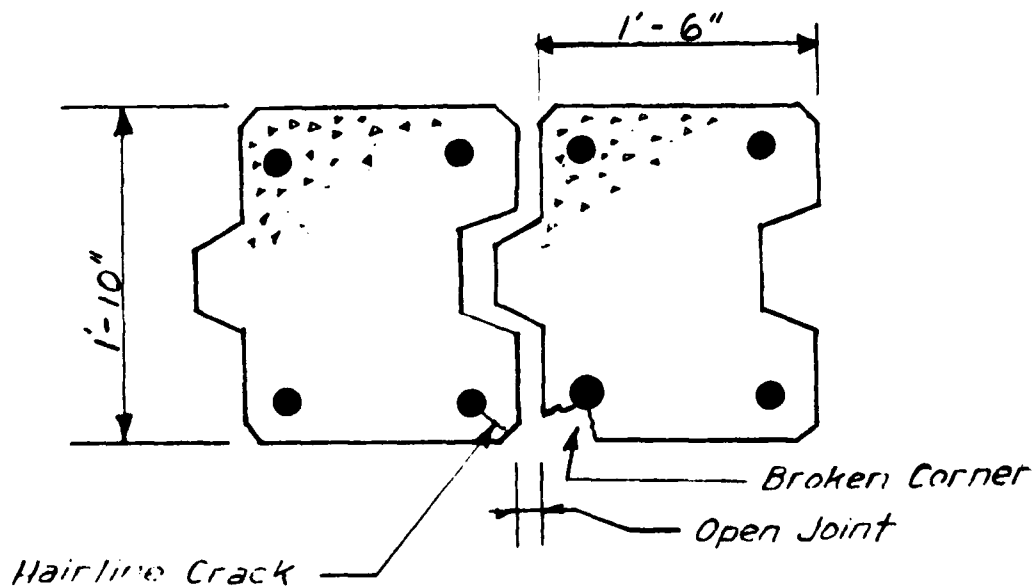
FIGURE 10 CONCRETE SHEET PILE DETERIORATION

The concrete sheet piling of Piers 3, 4, 5 and 6 is in fair to good condition. There are areas of cracking, broken concrete, and misaligned piles, but the distress does not extend into the concrete beyond the reinforcing steel. There is no evidence of significant loss of cross section; no evidence of active deterioration; and no evidence of structural failure.

There is also no indication that the defects and damage found during the inspection occurred over time rather than as a result of construction. It is likely that the cracks on the chamfers of the piles occurred during curing or handling; and the broken tongues and grooves, and the misaligned piles were probably caused by construction operations. The piles are continuously submerged, and set back from the face of the pier so that they are not usually subject to damage from the environment or external forces. It is, therefore, recommended that the design loading indicated below be maintained.
